**Flood Control Project Maintenance
Levee Inspections**

Maintenance Issue Types Only, Levee Inspection Report By Mile - Spring 2019

Sutter Maintenance Yard Hamilton Bend

Waterway	Bank	Unit Miles	Inspection Start/End	Inspector
Unit No. 01 Feather River Hamilton Bend	Right	3.39	04/04/2019 04/04/2019	Sterling York

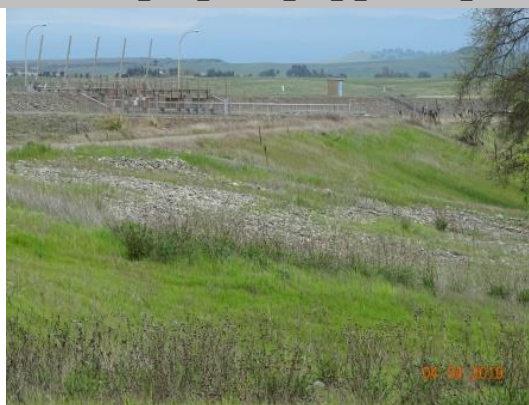
Photo 1 of 1 : SP_2019_ST0005_289_5_20190409_00015.jpg

LM Start	0.00	Rating **	A	Issue No.	5
LM End	1.37	Issue Type +	Ma	Location *	WS
Category	Earthen Levee			GPS Latitude/Longitude	
				Start	End
Item	Vegetation			39.439671 °	39.457917 °
				-121.641410 °	-121.638319 °
DWR ID	DWR_ST0005_01_s_2019_5				
Comment Code					
V1 : Control annual grass and weeds on the levee slopes and easements.					
Inspector Comment					
From levee mile 0.00 to levee mile 1.37 the annual vegetation is well maintained, Spring 2019.

View looking upstream waterside from levee mile 0.00 to levee mile 1.37 where annual vegetation is well maintained, Spring 2019.

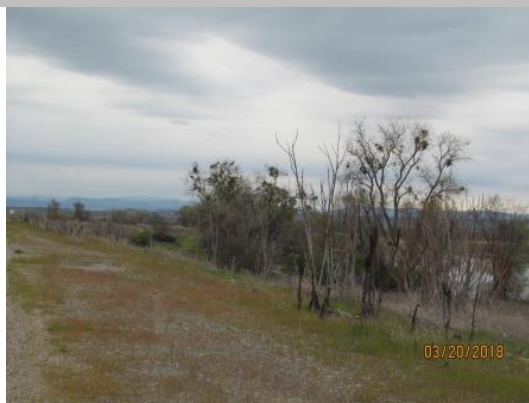
Photo 1 of 1 : SP_2019_ST0005_289_14_20190305_00005.jpg

LM Start	0.73	Rating **	A	Issue No.	14
LM End	0.91	Issue Type +	Ma	Location *	WS
Category	Earthen Levee			GPS Latitude/Longitude	
				Start	End
Item	Trim / Thin Trees			39.450109 °	39.452643 °
				-121.640851 °	-121.640316 °
DWR ID	DWR_ST0005_01_s_2016_14				
Comment Code					
T3 : Trim and thin trees to allow visibility of the ground and room to flood fight.					
Inspector Comment					
Small trees 4" in diameter at chest height have been sprayed and should be removed, Fall 2018.

View looking upstream waterside of trees. Small trees 4" in diameter at chest height have been sprayed and should be removed, Spring 2018.

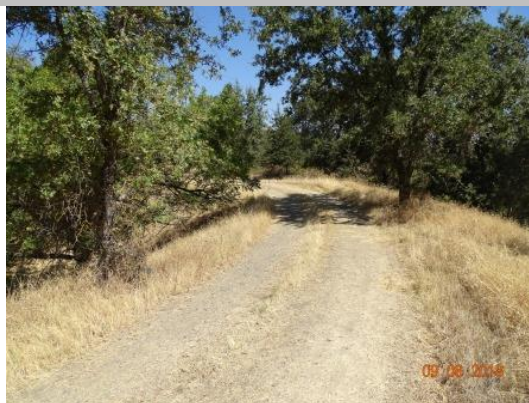
Photo 1 of 1 : SP_2019_ST0005_289_11_20190305_00004.jpg

LM Start	1.48	Rating **	U	Issue No.	11
LM End	3.25	Issue Type +	Ma	Location *	LS
Category	Earthen Levee			GPS Latitude/Longitude	
				Start	End
Item	Trim / Thin Trees			39.458055 °	39.470312 °
				-121.636300 °	-121.609242 °
DWR ID	DWR_ST0005_01_s _ 2017_11				
Comment Code					
T3 : Trim and thin trees to allow visibility of the ground and room to flood fight.					
Inspector Comment					
Trim/Thin Trees from Levee Mile 1.48 to 3.25. The LMA does not maintain the levee from Levee Mile 1.38 to 3.39.

View looking upstream landside and waterside of thick trees blocking visibility on landside, Fall 2018.

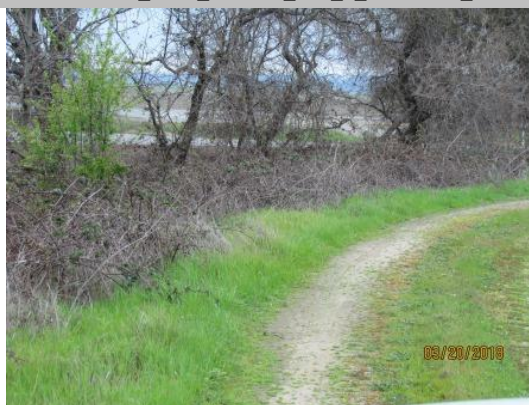
Photo 1 of 1 : SP_2019_ST0005_289_6_20190305_00002.jpg

LM Start	1.50	Rating **	U	Issue No.	6	
LM End	2.63	Issue Type +	Ma	Location *	LS	
Category	Earthen Levee			GPS Latitude/Longitude		
				Start		End
Item	Vegetation			39.458132 °		39.466025 °
				-121.635914 °		-121.618972 °
DWR ID	DWR_ST0005_01_f_2016_6					
Comment Code						
V2 : Remove the wild growth other than native grasses from the levee slopes.						
Inspector Comment						
Blackberries covering slope from Levee Mile 1.50 to 2.63. The LMA does not maintain the levee from Levee Mile 1.38 to 3.39.

View looking upstream landside of blackberries that are covering the landside slope, Spring 2018.

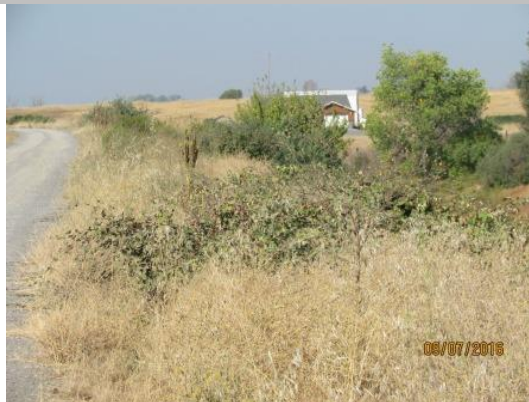
Photo 1 of 1 : SP_2019_ST0005_289_10_20190305_00003.jpg

LM Start	2.46	Rating **	U	Issue No.	10
LM End	2.48	Issue Type +	Ma	Location *	LS
Category	Earthen Levee			GPS Latitude/Longitude	
				Start	End
Item	Vegetation			39.465370 °	39.465410 °
				-121.622074 °	-121.621736 °
DWR ID	DWR_ST0005_01_f_2016_10				
Comment Code					
V2 : Remove the wild growth other than native grasses from the levee slopes.					
Inspector Comment					
Blackberries covering slope from Levee Mile 2.46 to 2.48. The LMA does not maintain the levee from Levee Mile 1.38 to 3.39.

View of blackberries that are covering landside slope.
